~~LEVEL II~~
**FLOOD PLAIN
INFORMATION
REPORT**

**OWASCO INLET
AND
HEMLOCK CREEK
VILLAGES OF MORAVIA AND LOCKE
CAYUGA COUNTY, NEW YORK**

PREPARED THROUGH THE COORDINATION OF THE NEW YORK STATE DEPARTMENT
OF ENVIRONMENTAL CONSERVATION BY THE DEPARTMENT OF THE ARMY, BUFFALO
DISTRICT, CORPS OF ENGINEERS, BUFFALO, NEW YORK.

JULY 1976

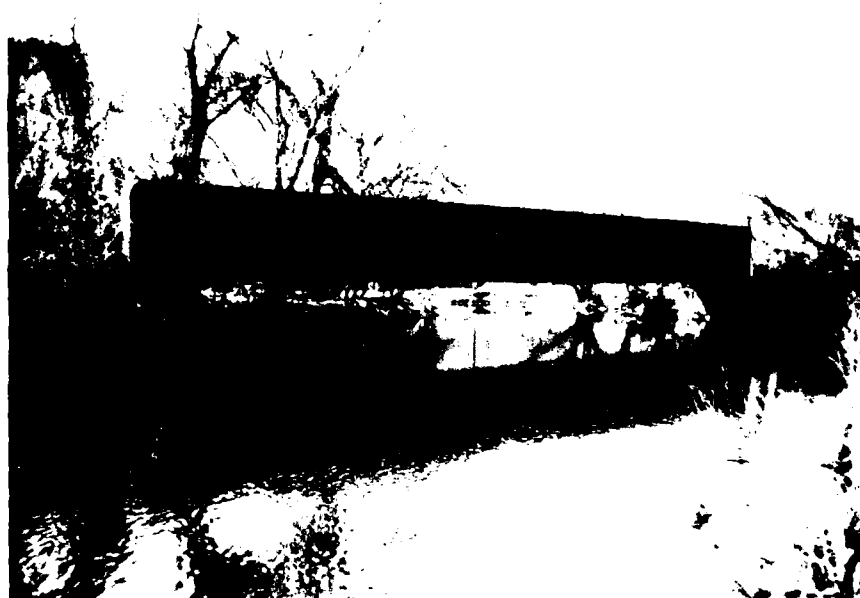
Figure 1 - Upstream face of the Lehigh Valley Railroad Bridge at Stream Mile 6.0.

Most of the 17 bridges which cross the inlet within the study area obstruct flood flows to some degree. The Lehigh Valley Railroad (LVRR) bridge, Figure 1, at mile 6.0 constricts high flows and diverts a portion of them to the east side of the LVRR tracks running north and south on the flood plain at that point. The LVRR bridge at mile 9.3, Figure 2, is built on timber piles which collect debris as is evident in the photo. Only its rather large size prevents it from being a major flow obstruction. Both the LVRR bridge at mile 8.8 on Hemlock Creek, Figure 3, and the Route 38 bridge 30' downstream are built on timber piles. The Route 38 bridge is an obstruction to high flows.

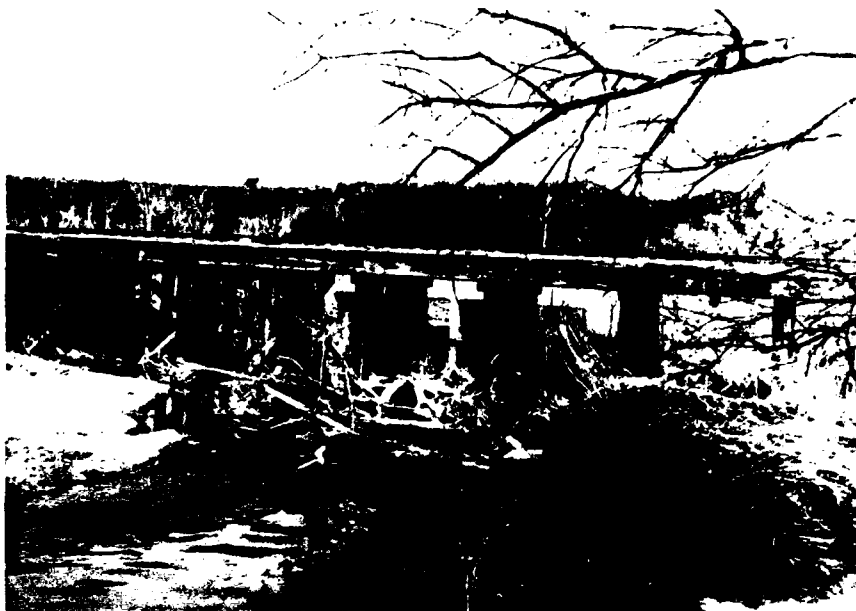
Figure 2 - Upstream face of the Lehigh Valley Railroad Bridge at Stream Mile 9.31. Note debris at face of bridge. Route 38 bridge in background.

The trees which line the banks of the Inlet for most of its length are a potential source of debris which could clog bridge openings during a flood. Figure 2 shows present debris conditions at the Lehigh Valley Railroad bridge at mile 9.3.

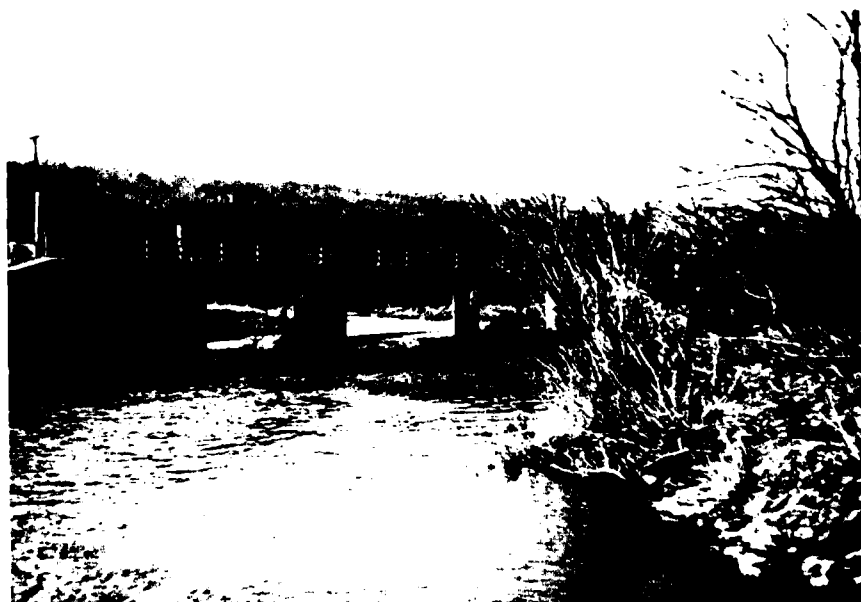
Figure 7 - Upstream face of the new Route 38 bridge at Stream Mile 7.98.

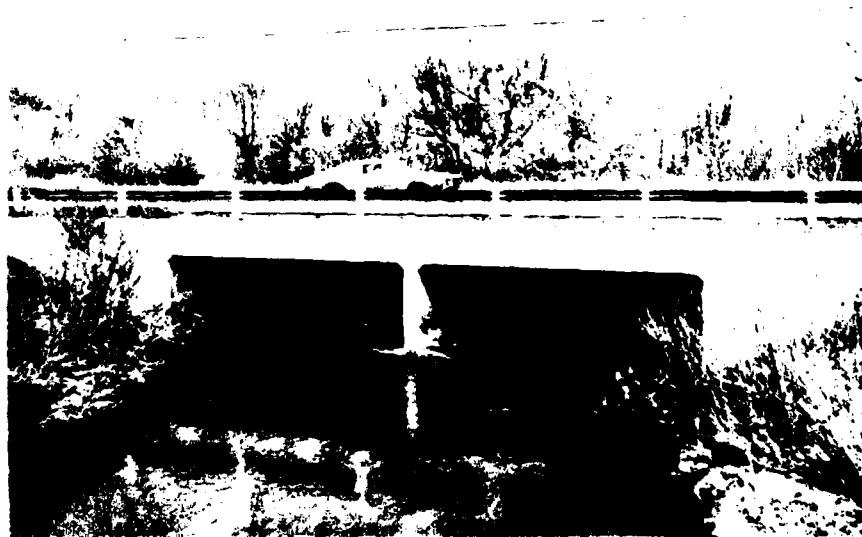
Figure 9 - Upstream face of the Route 38 bridge at Mile 9.29.

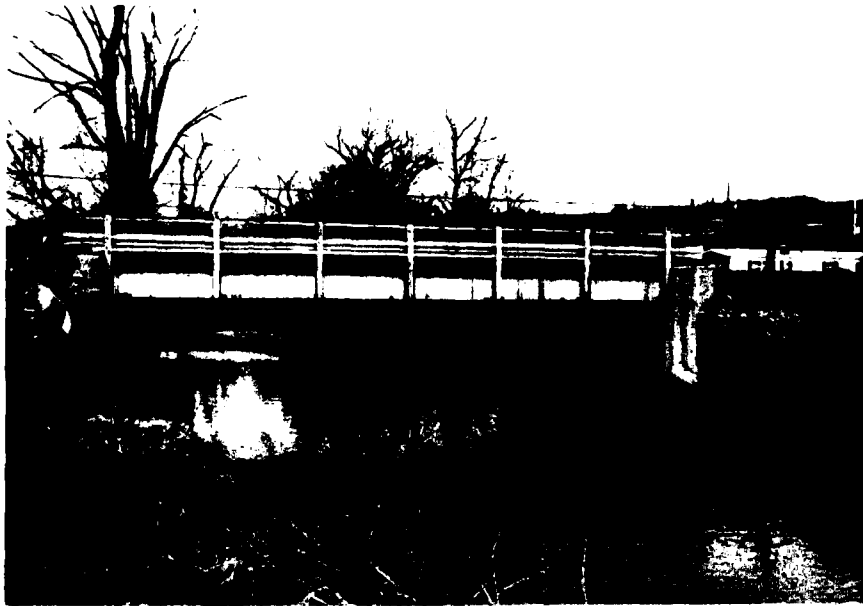
Figure 10 - Upstream face of the Cat Path Road bridge at Stream Mile 9.45.

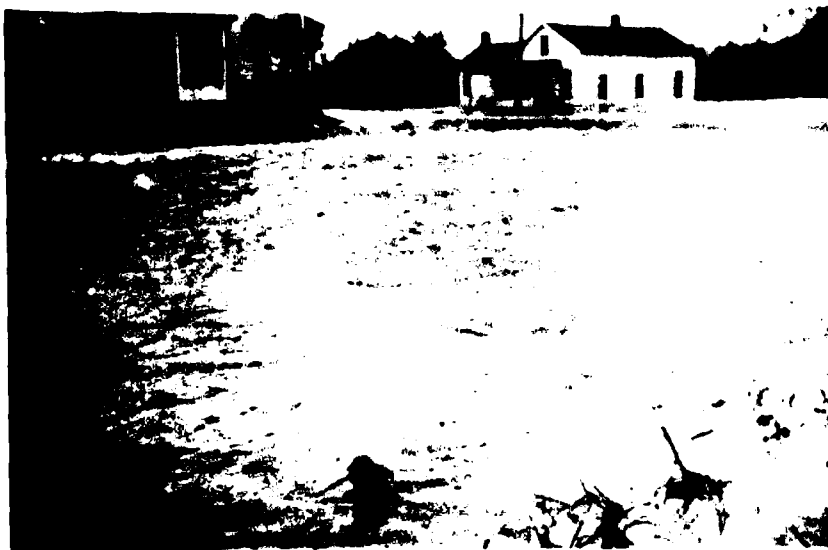
Figure 12 - Storm of 1935 flood conditions at Route 90, Locke, NY. Just downstream of confluence with Berlock Creek, Stream Mile 8.65.

July 1935 - This storm, centered over south-central New York, consisted of a series of thunder showers occurring during the period 6-9 July. The heaviest precipitation occurred in an area from Keuka Lake to central Chenango County, in extent approximately 100 miles from west to east, and 15-20 miles from north to south. The southern portion of the Owasco Inlet Watershed extends into that area, wherein rainfall for 7-8 July exceeded nine inches. In Moravia, flood depths of one foot and two feet occurred in the business and residential sections, respectively. Figures 11 and 12 depict flooding conditions at Locke, NY during the flood.

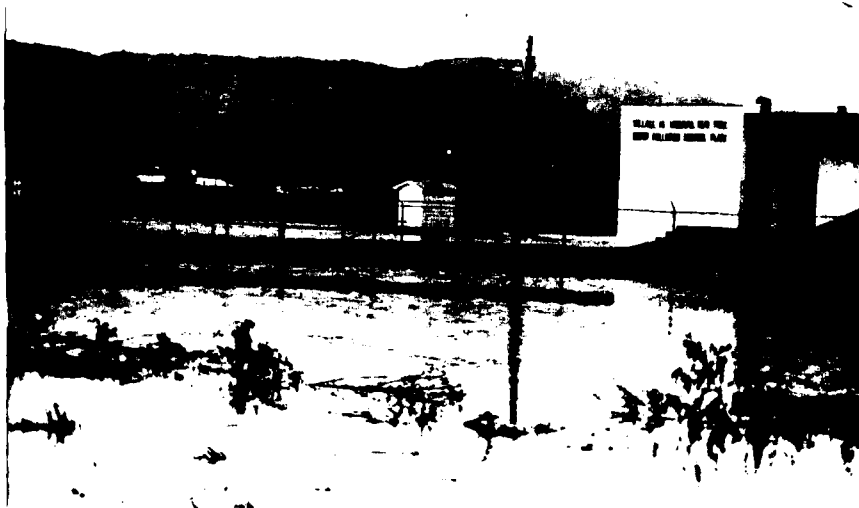
Figure 14 - Flooding conditions at village of Moravia Water Pollution Control Plant, on Long Hill Road during September 1975 high water. Stream Mile 4.5.

Figures 13 and 14 depict flooding conditions at Moravia during the storm.

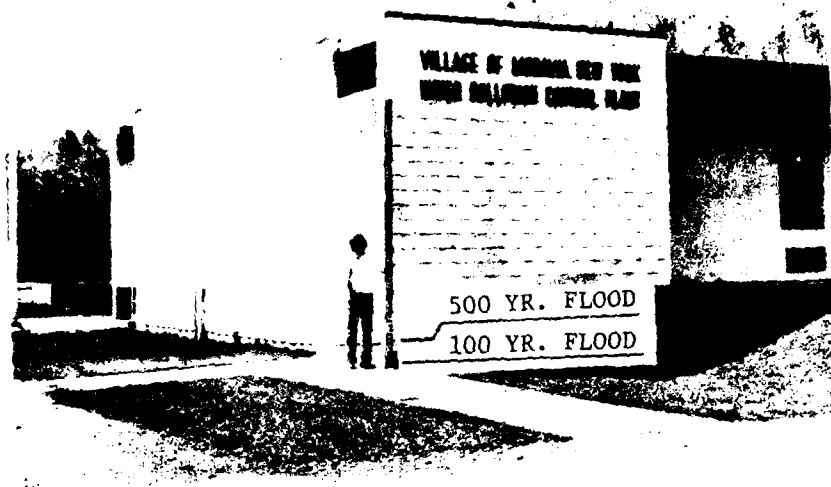
Figure 15 - Future flood heights at village of Moravia Water Pollution Control Plant, Stream Mile 4.5.

Photographs, future flood heights - The expected levels of the 100- and 500-year floods for locations in the study area are indicated on Figures 15 and 16.

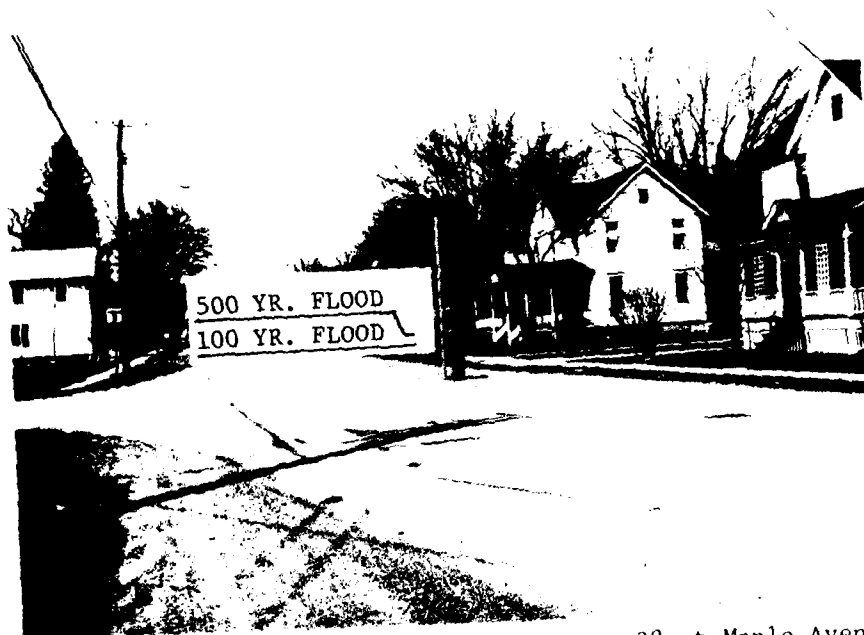
Figure 16 - Future flood heights on Route 38 at Maple Avenue, Locke, NY near Stream Mile 8.65.
